EXPERIMENTATION AND FRAMEWORK DEVELOPMENT FOR MULTI-VOLCANIC HAZARD IMPACT ASSESSMENT

NICOLE ALLEN⁽¹⁾, THOMAS WILSON⁽¹⁾, BEN KENNEDY⁽¹⁾, ALLAN SCOTT⁽¹⁾, CAROL STEWART⁽²⁾ (1) UNIVERSITY OF CANTERBURY (2) MASSEY UNIVERSITY

TEPHRA LOADING EXPERIMENT OBJECTIVES

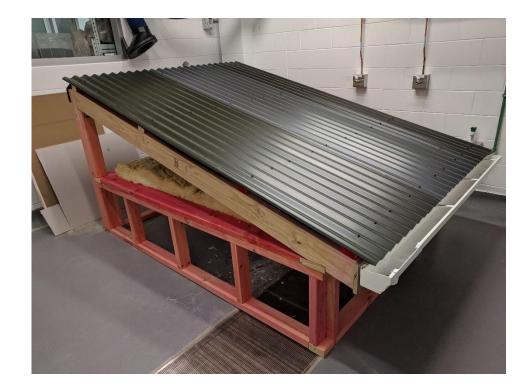
- Load 7.7kPa (dry load), 9.5kPa (wet load)
- Approximately 4 tonnes

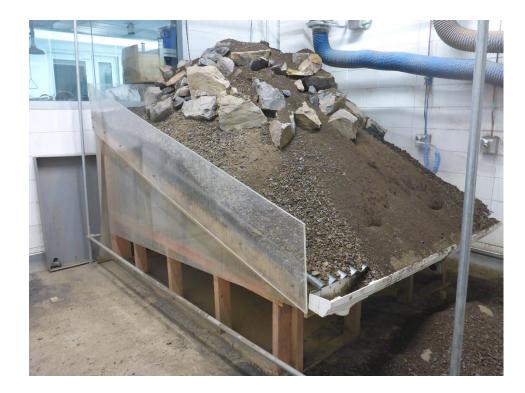
- Initial structural damage occurred at the fixings where the rafters connect to the ridge beam.
- Initial structural damage 13.4kPa (dry load), 16.8kPa (wet load)

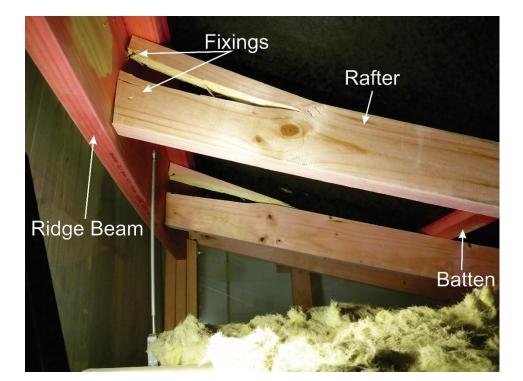
- Once rafter failure occurred, batten failure occurred
- A total of 7.5 tonnes of pseudo tephra were applied to the roof
- Total load 14.9kPa (dry load), 18.7kPa (wet load)

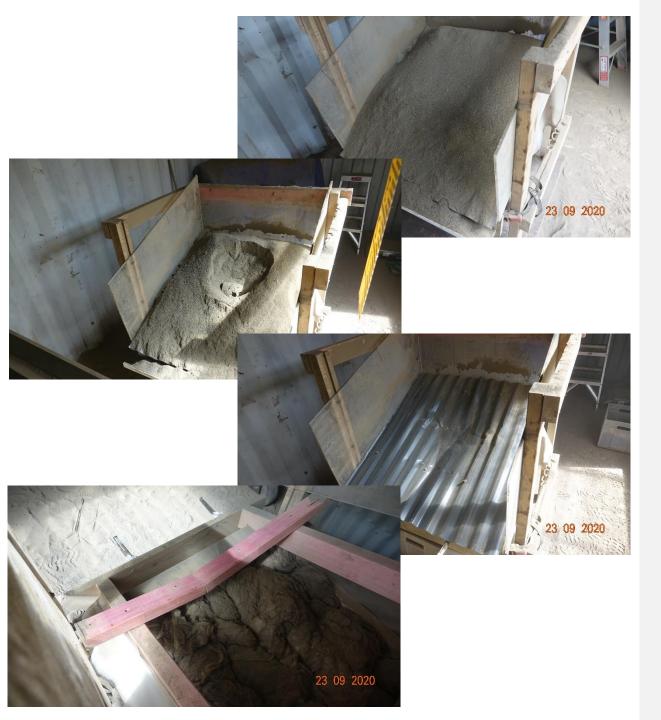
- Ash
 - Load 2kPa
 - Thickness 15cm
- Ballistic
 - Mass 3.5kg
 - Velocity 21 m/s
 - Energy 819J

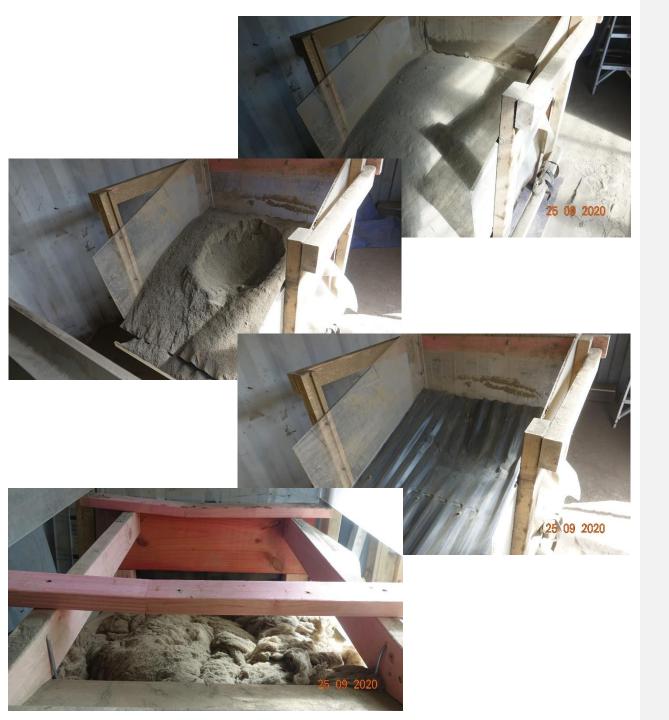
- Ash
 - Load 2kPa
 - Thickness 17cm
- Ballistic
 - Mass 3.5kg
 - Velocity 31 m/s
 - Energy 1767J

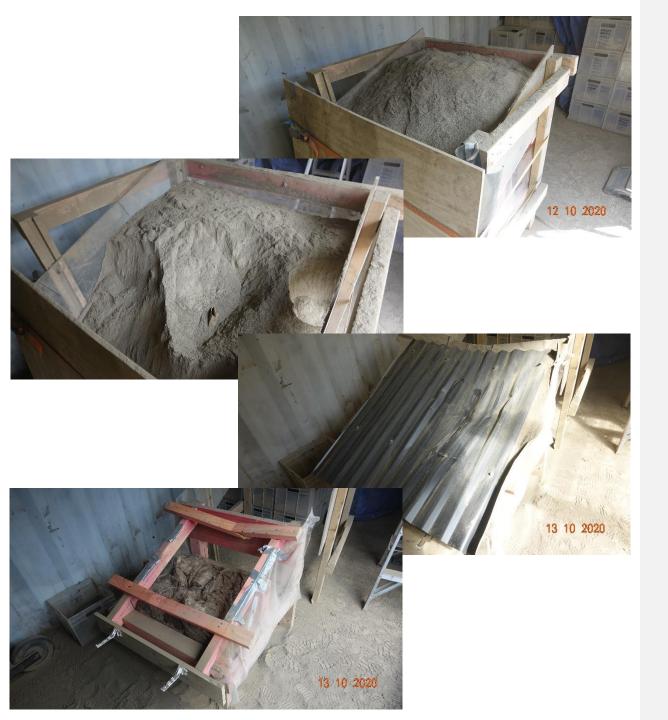
- Ash
 - Load 2kPa
 - Thickness 17cm
- Ballistic
 - Mass 3.5kg
 - Velocity 45m/s
 - Energy 3865J

Tephra can cushion ballistic impacts, protecting cladding from perforation, but higher impacts energies can lead to structural damage

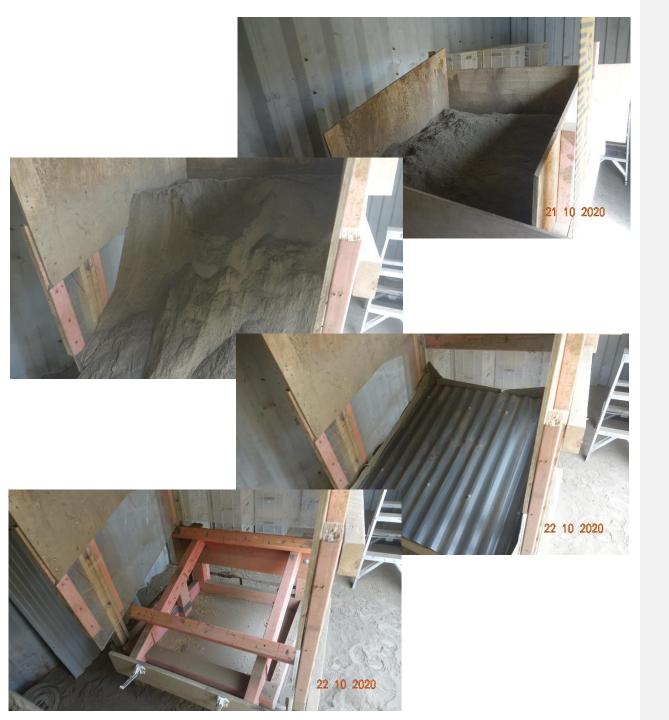
- Ash
 - Load 7.5kPa
 - Thickness 45cm
- Ballistic
 - Mass 8.8kg
 - Velocity 32m/s
 - Energy 4505J

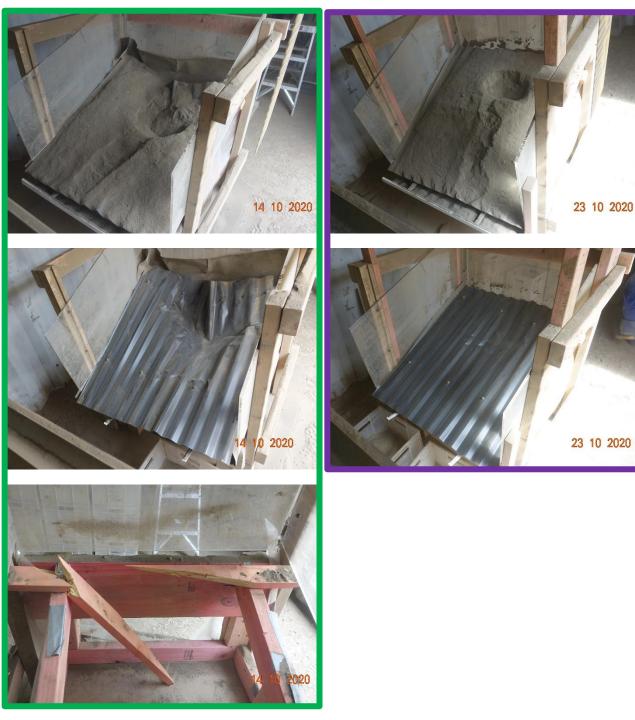
- Ash
 - Load I I kPa
 - Thickness 61 cm
- Ballistic
 - Mass 8.8kg
 - Velocity 32m/s
 - Energy 4592J

Large loads of tephra can dissipate the energy of ballistics, potentially leading to no or little impact occurring

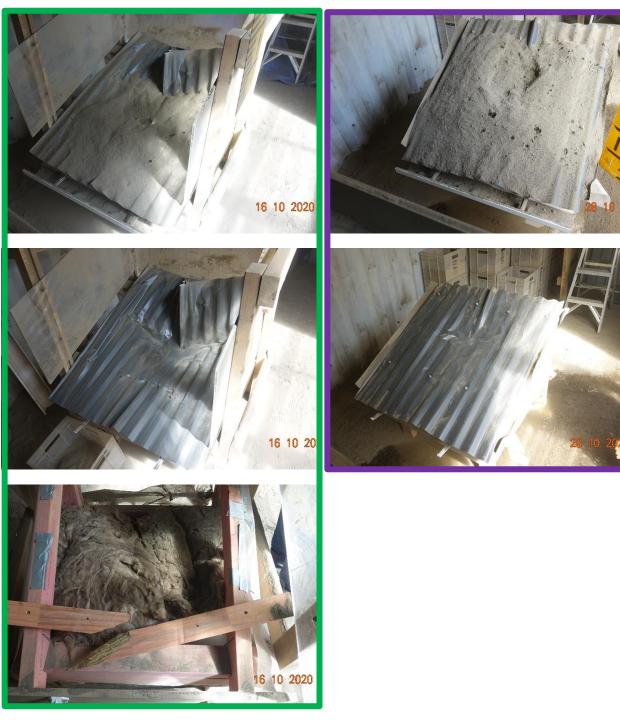
- 2
- Ash Ash
 - Load IkPa
 Load IkPa
 - Thickness 7cm
 Thickness 9cm
- Ballistic
 Ballistic
 - Mass 3.5kg Mass 1kg
 - Velocity 36m/s Velocity 47m/s
 - Energy 2486J Energy 1075J

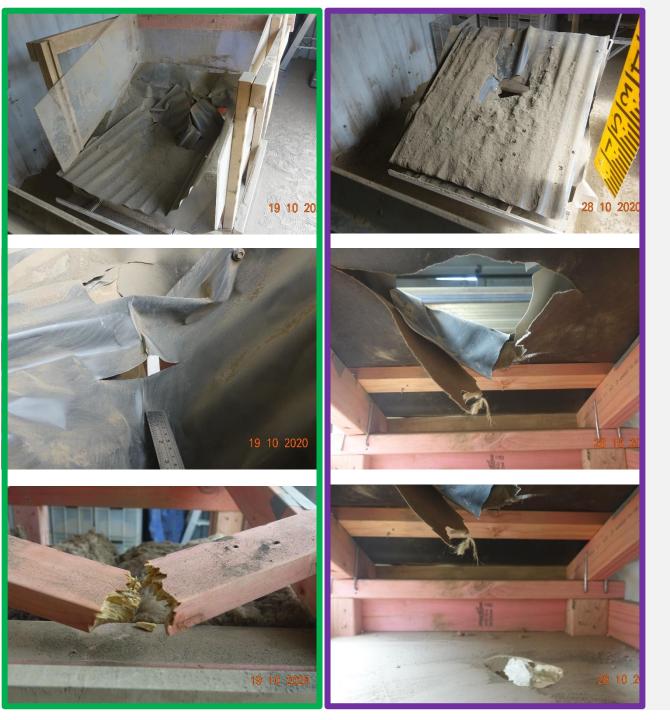
- 2
- Ash • Ash
 - Load 0.5kPa
 Load 0.5kPa
 - Thickness 4cm
 Thickness 3.5cm
- Ballistic • Ballistic
 - Mass 3.5kg Mass – Ikg
 - Velocity 50m/s
 Velocity 44m/s
 - Energy 4623J Energy 941J •
