EXPERIMENTATION AND FRAMEWORK DEVELOPMENT FOR MULTI-VOLCANIC HAZARD IMPACT ASSESSMENT

NICOLE ALLEN⁽¹⁾, THOMAS WILSON⁽¹⁾, BEN KENNEDY⁽¹⁾, ALLAN SCOTT⁽¹⁾, CAROL STEWART⁽²⁾ (1) UNIVERSITY OF CANTERBURY (2) MASSEY UNIVERSITY

TEPHRA LOADING EXPERIMENT OBJECTIVES

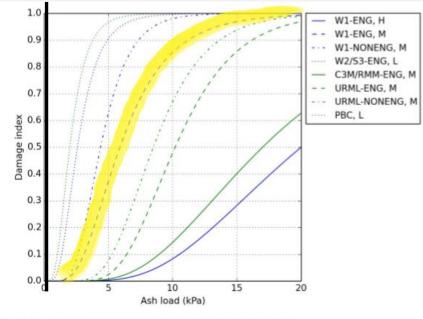
- Built to New Zealand building code NZS3604
- Rafter span 2.6m, Rafter spacing 600mm
- The building standard incorporates a 2kPa snow load (approximately 12cm of tephra)

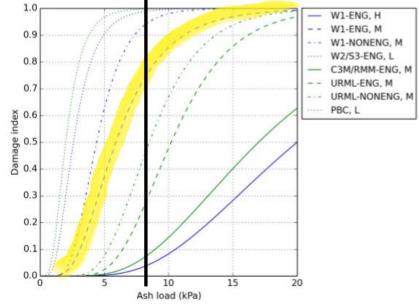
- Load 7.7kPa (dry load), 9.5kPa (wet load)
- Approximately 4 tonnes

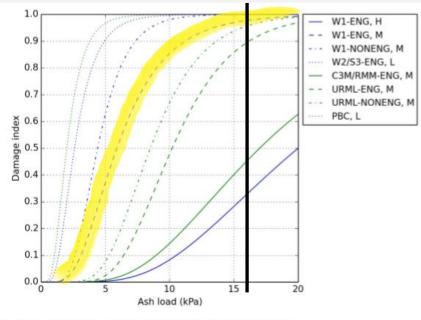
- Initial structural damage occurred at the fixings where the rafters connect to the ridge beam.
- Initial structural damage 13.4kPa (dry load), 16.8kPa (wet load)

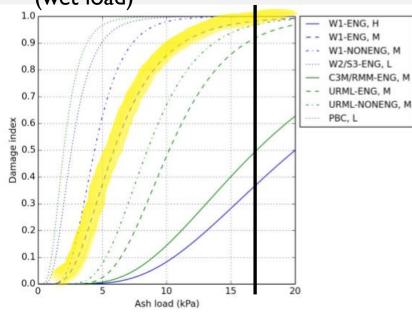
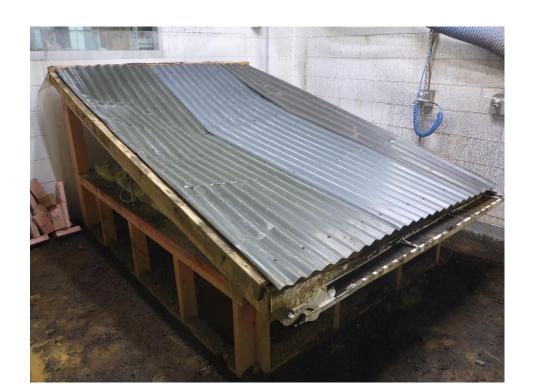
- Once rafter failure occurred, batten failure occurred
- A total of 7.5 tonnes of pseudo tephra were applied to the roof
- Total load 14.9kPa (dry load), 18.7kPa (wet load)

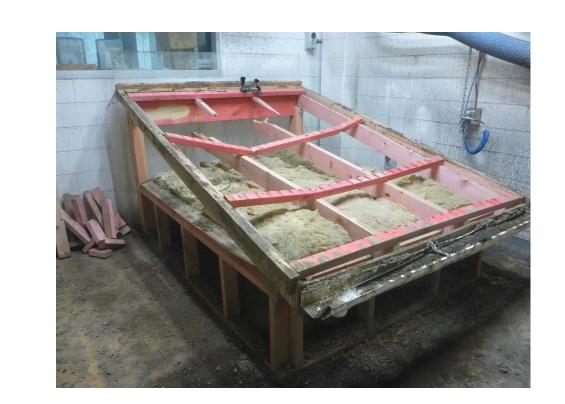
- Once rafter failure occurred, batten failure occurred
- A total of 7.5 tonnes of pseudo tephra were applied to the roof
- Total load 14.9kPa (dry load), 18.7kPa (wet load)

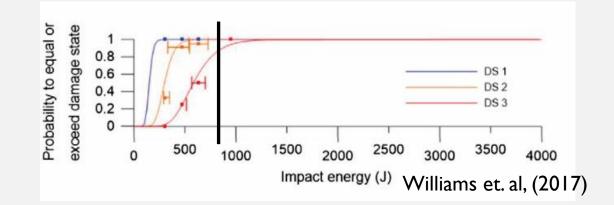
- Ash
 - Load 2kPa
 - Thickness 15cm
- Ballistic
 - Mass 3.5kg
 - Velocity 21 m/s
 - Energy 819J

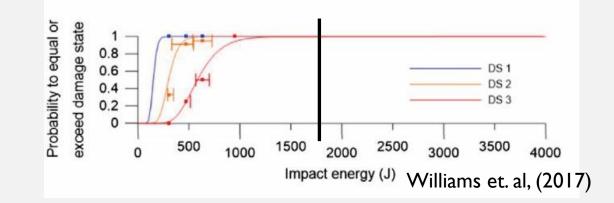
- Ash
 - Load 2kPa
 - Thickness 17cm
- Ballistic
 - Mass 3.5kg
 - Velocity 31 m/s
 - Energy 1767J

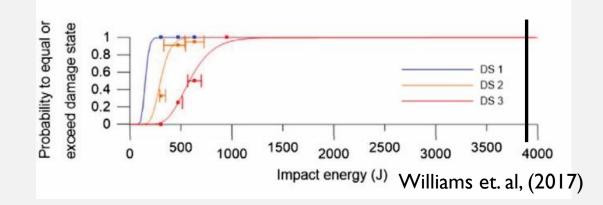
- Ash
 - Load 2kPa
 - Thickness 17cm
- Ballistic
 - Mass 3.5kg
 - Velocity 45m/s
 - Energy 3865J

Tephra can cushion ballistic impacts, protecting cladding from perforation, but higher impacts energies can lead to structural damage

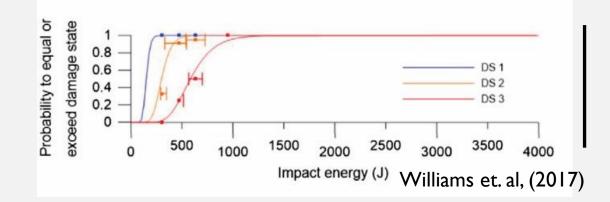
- Ash
 - Load 7.5kPa
 - Thickness 45cm
- Ballistic
 - Mass 8.8kg
 - Velocity 32m/s
 - Energy 4505J

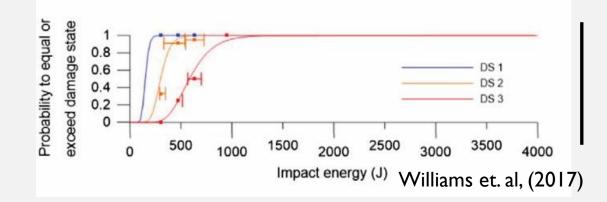
- Ash
 - Load I I kPa
 - Thickness 61 cm
- Ballistic
 - Mass 8.8kg
 - Velocity 32m/s
 - Energy 4592J

Large loads of tephra can dissipate the energy of ballistics, potentially leading to no or little impact occurring

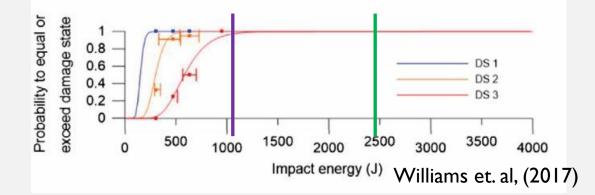
- 2
- Ash Ash
 - Load IkPa
 Load IkPa
 - Thickness 7cm
 Thickness 9cm
- Ballistic
 Ballistic
 - Mass 3.5kg Mass 1kg
 - Velocity 36m/s Velocity 47m/s
 - Energy 2486J Energy 1075J

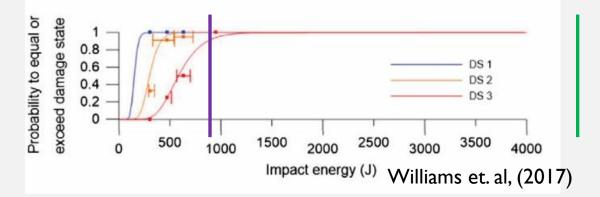
- 2
- Ash • Ash
 - Load 0.5kPa
 Load 0.5kPa
 - Thickness 4cm
 Thickness 3.5cm
- Ballistic • Ballistic
 - Mass 3.5kg Mass – Ikg
 - Velocity 50m/s
 Velocity 44m/s
 - Energy 4623J Energy 941J •

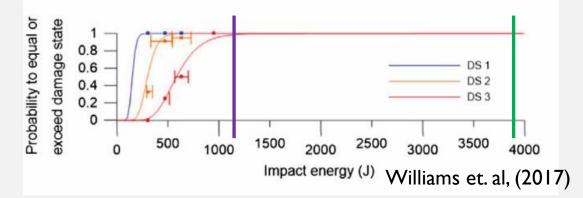
- 2
- Ash • Ash
 - Load 0.25kPa
 Load 0.25kPa
 - Thickness 2cm
 Thickness 1.5cm
- Ballistic
 - Ballistic
 - Mass 3.5kg Mass – Ikg
 - Velocity 46m/s
 Velocity 49m/s
 - •
- Energy 3865J Energy 1138J

The size of the ballistic, rather than the impact energy, controls whether a ballistic can penetrate sheet metal cladding
